Technical Report CHL-97-17
August 1997

Periodic Inspection of Humboldt Bay Jetties, Eureka, California

Report 1

Base Conditions

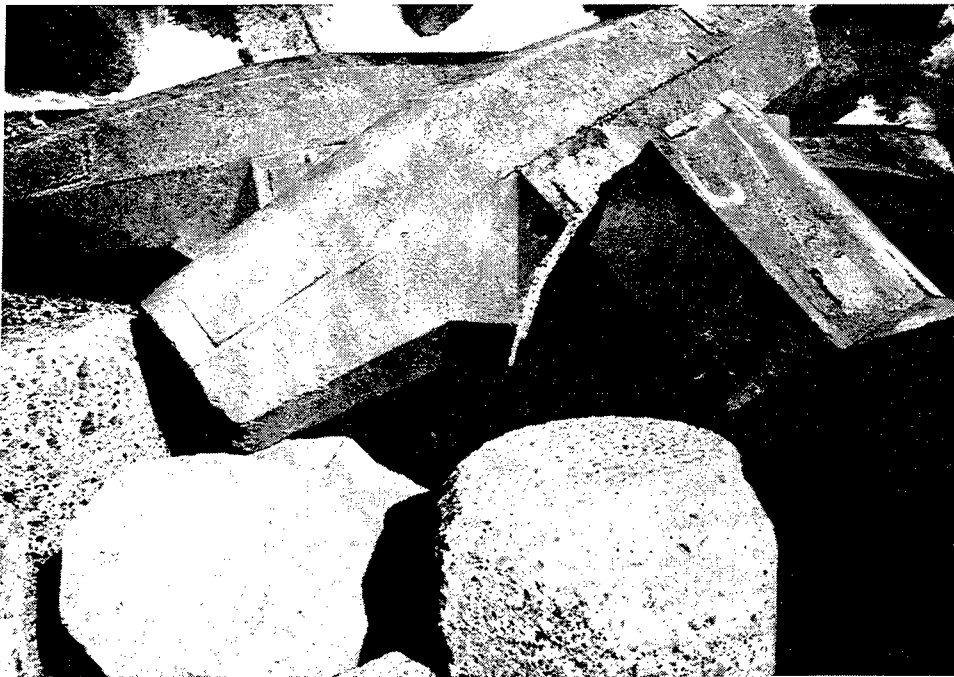
Figure 20. Dolos with straight, shank-fluke break

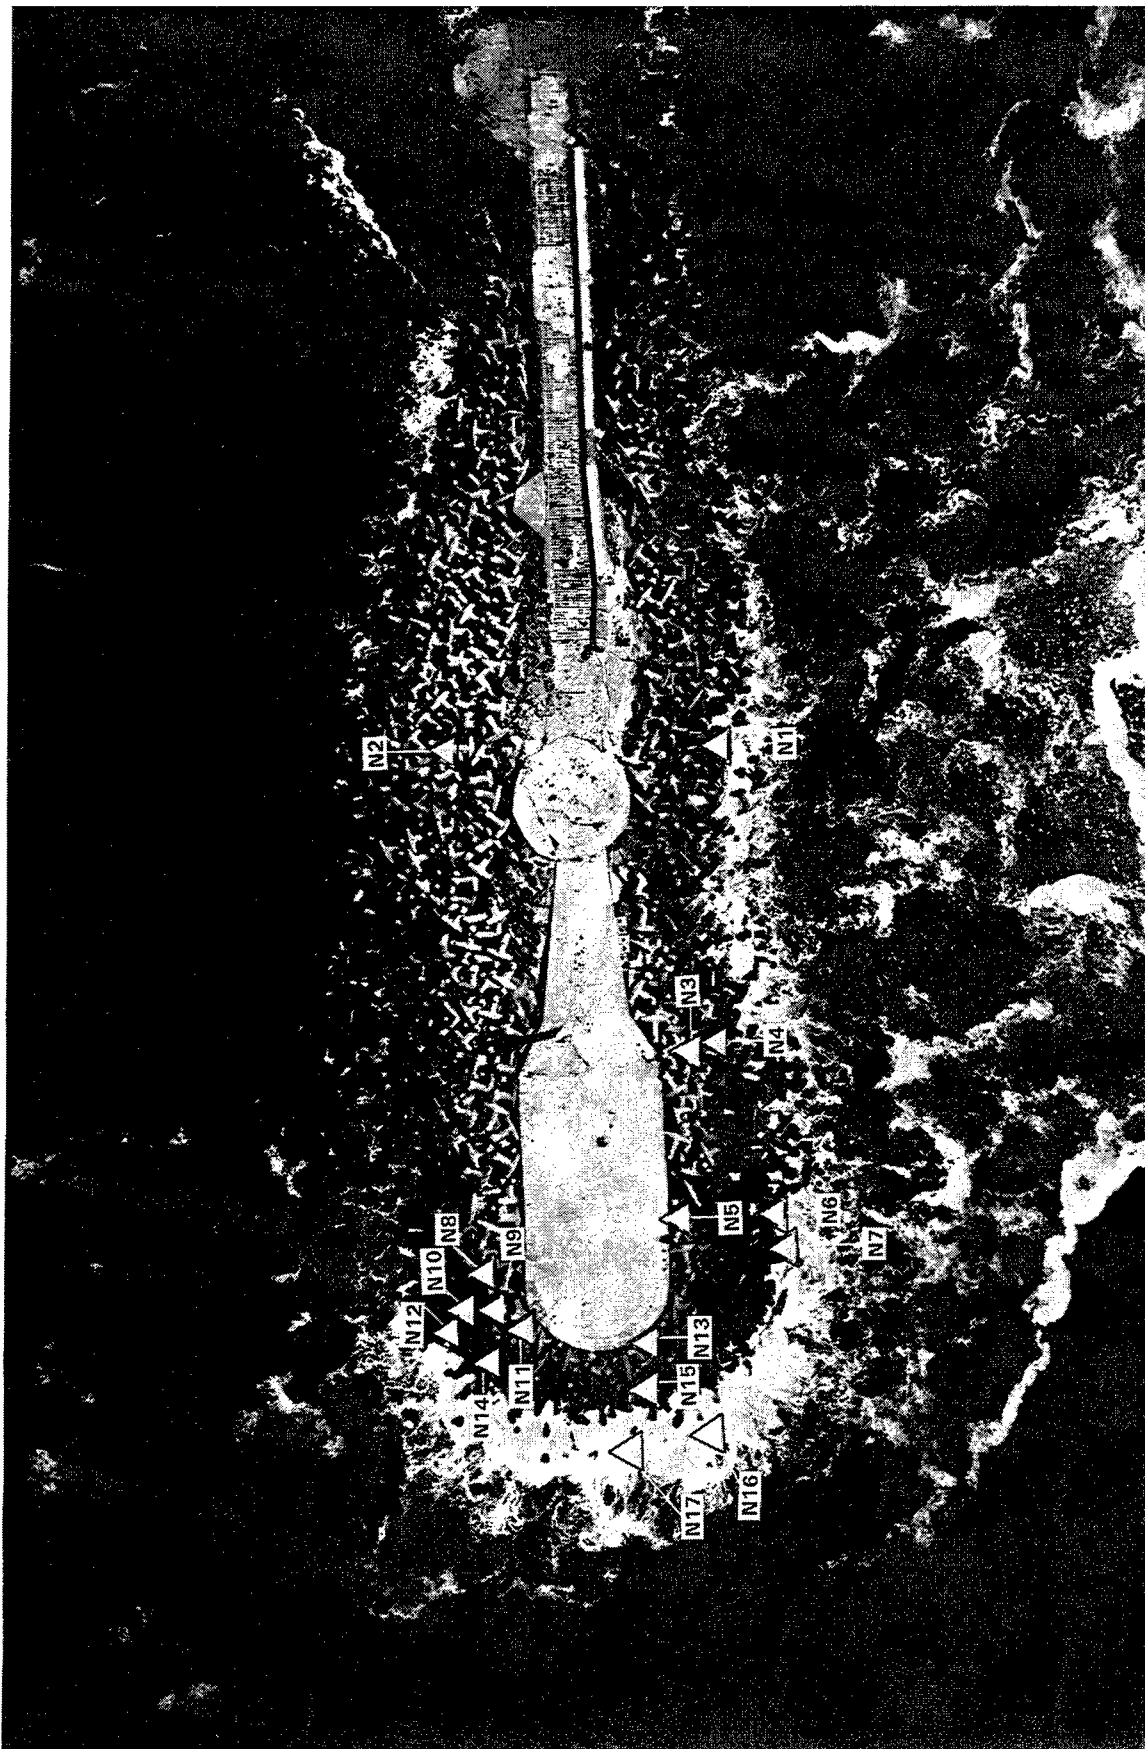
Figure 21. Approximate locations of broken/cracked dolos armor units on the north jetty

Armor Unit No.	Station No.	Offset from Baseline m (ft)		Type of Break, Comments
		Seaside	Channelside	
N1	71 + 17		25.30 (83)	Straight mid-shank break
N2	71 + 17	22.86 (75)		Straight mid-shank break
N3	72 + 90		18.29 (60)	Straight shank-fluke crack
N4	72 + 90		21.95 (72)	Straight mid-shank break
N5	73 + 82		14.63 (48)	Straight shank-fluke break
N6	73 + 82		32.00 (105)	Straight mid-shank break
N7	74 + 00		33.53 (110)	Angled mid-shank break
N8	74 + 10	18.29 (60)		Straight shank-fluke break
N9	74 + 30	16.76 (55)		Straight fluke-shank break
N10	74 + 30	21.34 (70)		Straight shank-fluke break
N11	74 + 40	12.19 (40)		Straight mid-shank break
N12	74 + 40	24.38 (80)		Straight fluke-shank break Angled mid-shank break
N13	74 + 55		15.24 (50)	Straight fluke-shank break
N14	74 + 65	18.29 (60)		Angled shank-fluke crack
N15	74 + 85		9.14 (30)	Straight fluke-shank break
N16	75 + 05		20.12 (66)	Straight fluke-shank break
N17	75 + 10		2.05 (10)	Straight mid-shank break

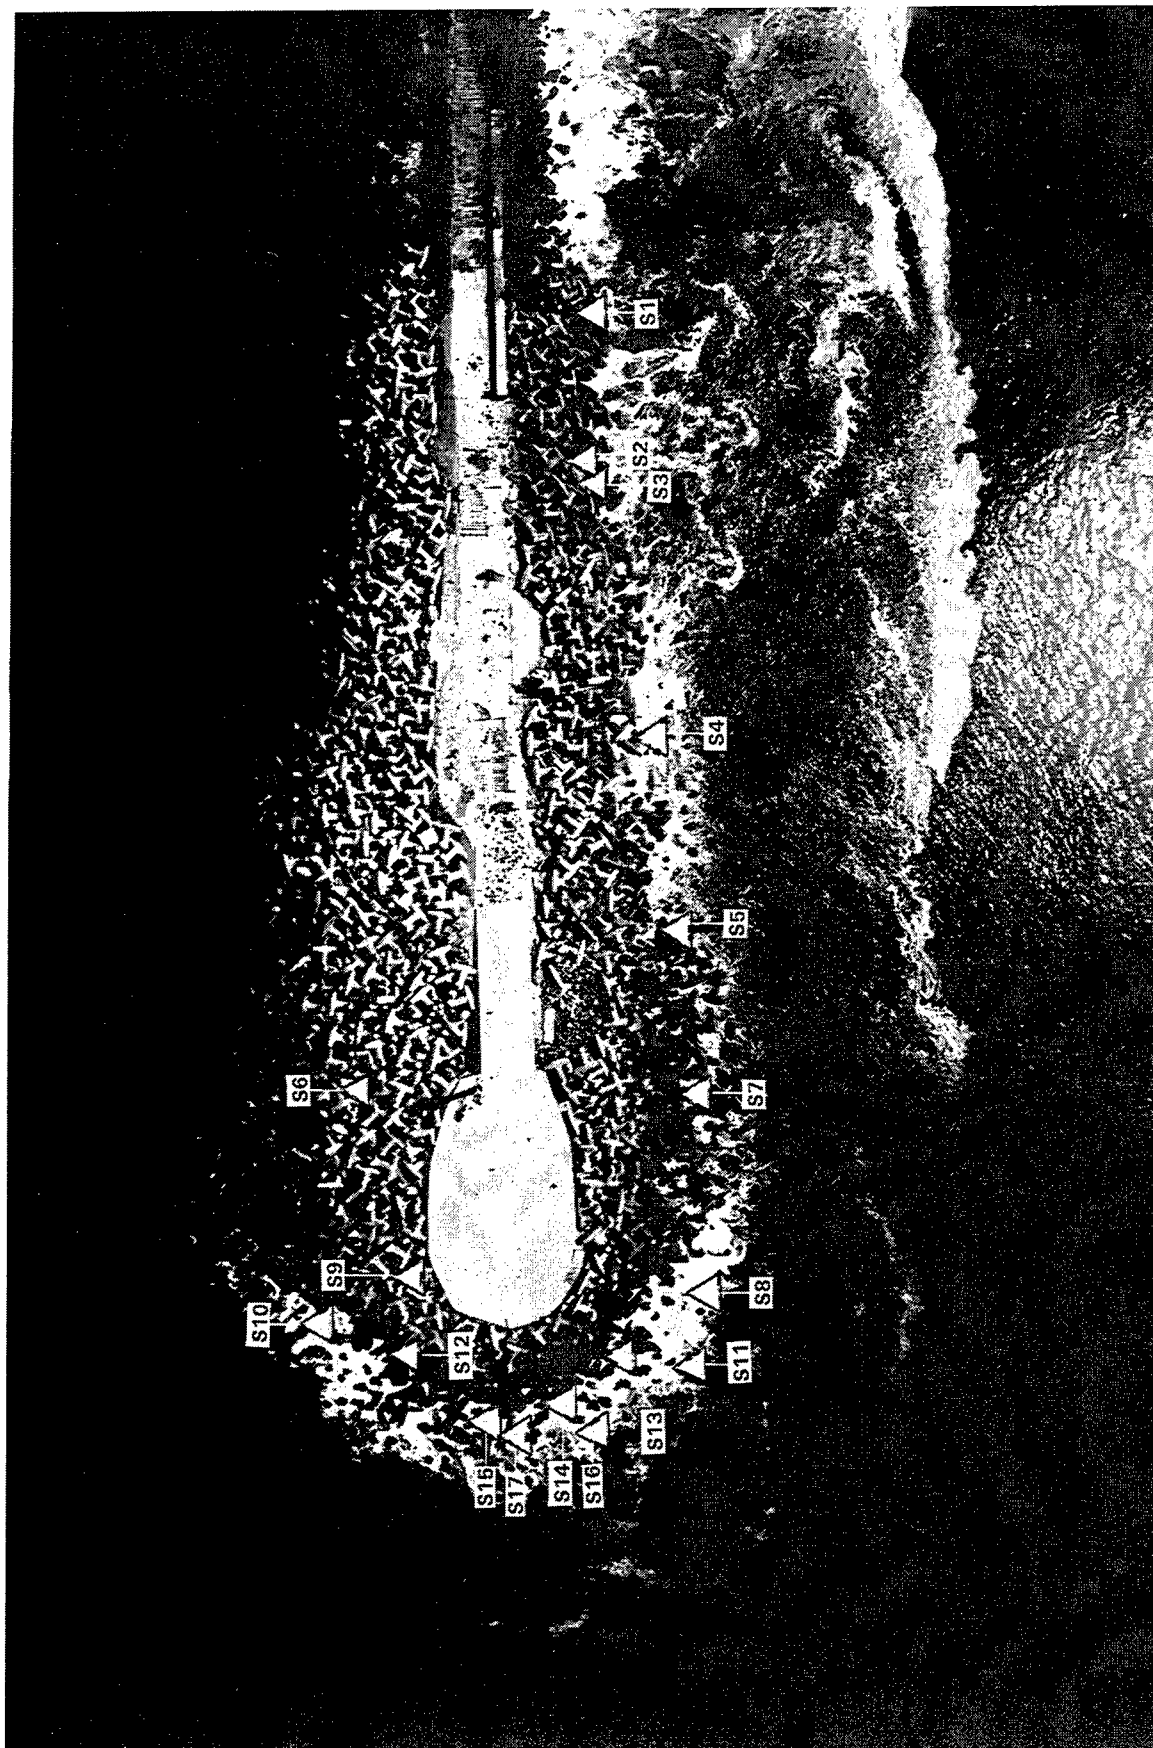
Figure 22. Approximate locations of broken/cracked dolos armor units on the south jetty

S1	84 + 59	21.95 (72)		Straight shank-fluke break
S2	85 + 36	18.29 (60)		Angled shank-fluke break
S3	85 + 45	18.29 (60)		Angled fluke-shank crack
S4	86 + 85	29.26 (96)		Angled fluke-shank crack
S5	88 + 00	31.09 (102)		Straight shank-fluke break
S6	88 + 90		25.60 (84)	Straight fluke-shank break
S7	89 + 08	34.75 (114)		Straight shank-fluke break
S8	90 + 00	36.89 (120)		Straight fluke-shank break
S9	90 + 00		15.24 (50)	Angled shank-fluke break
S10	90 + 24		33.53 (110)	Angled mid-shank break
S11	90 + 44	31.70 (104)		Straight fluke-shank break
S12	90 + 46		18.29 (60)	Straight shank-fluke break
S13	90 + 50	19.81 (65)		Straight mid-shank break
S14	90 + 70	9.14 (30)		Straight shank-fluke break
S15	90 + 80		3.05 (10)	Straight fluke-shank break
S16	90 + 84	14.02 (46)		Straight fluke-shank break
S17	100 + 90		0.61 (2)	Angled shank-fluke break
